Mount Zion Church Northeast Wall Stabilization Assessment Report

Report to Loudoun County Parks and Recreation
June 15, 2006

Produced by The John Greenwalt Lee Company

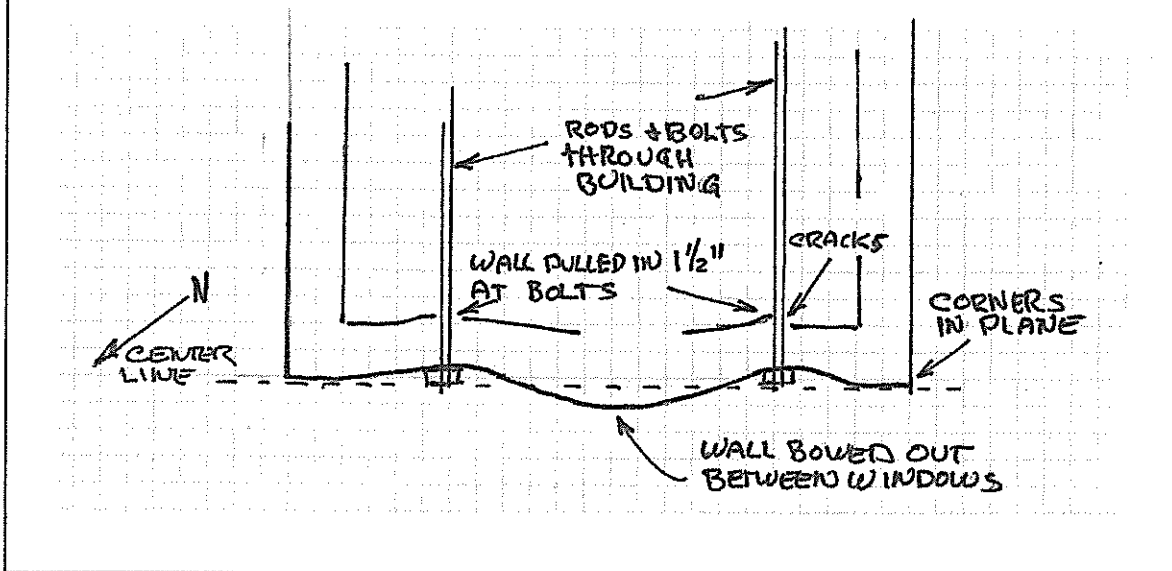
Representation of deflections in NW wall if viewed from above:

The overall deflection in the wall from corners to the center remains 1-1/2" out of plumb (inward in some areas, out in others). From top to bottom the wall bows out 1-1/2" in the middle, but the top and bottom of the wall are plumb.

This is not an alarming deflection, but all of the underlying problems related to water need to be adequately addressed, the foundation repaired, the bolts removed, and the masonry panels at the bolts and around the windows pulled back into their appropriate alignment.

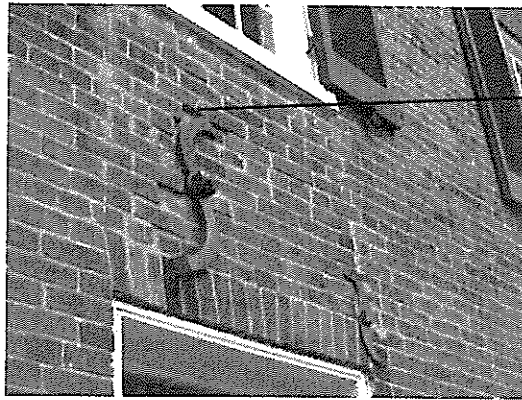
Early on our first afternoon at the site, while starting to map deflections, we realized the problem was not as it appeared. The restraint bolts had deformed and broken both the NW and SE walls. On the SE, the deflection at the window panel is a sharp $\frac{3}{4}$ " offset. On the NW wall, it pulled the column to the outside of the windows and the window panel inward by up to $1\frac{1}{2}$ ", however the wall deformed uniformly inward so that there are no sharp edges; rather an even inward curvature at and to the outside edge of the windows.

SE wall above entrance has sharp $\frac{3}{4}$ " inward deflection

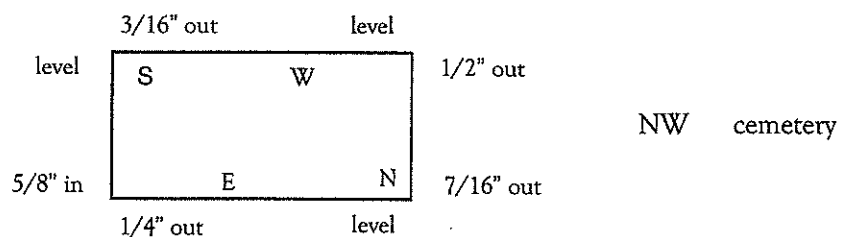
Corners out-of-level
in 4' readings:

For reference, there is some degree of lean at each of the four corners of the building; some outward, others inward. Only the East- and West-facing corners on the North end of the building and the West-facing corner of the South end are completely vertical. The other Southern corners are out $\frac{3}{16}$ - $\frac{5}{8}$ ". The cemetery-facing Northwest wall leans out $\frac{1}{2}$ " every 4'.

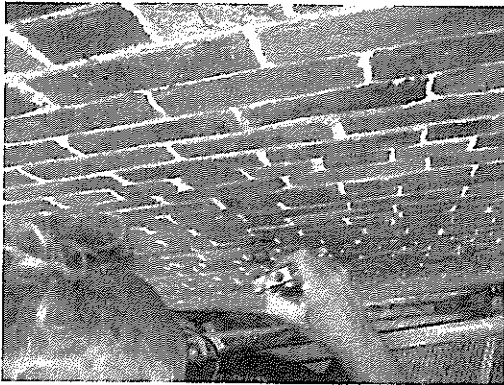
Hanging plumb bobs, pulling lines and using lasers helped determine the inward and outward deflections in the end wall.

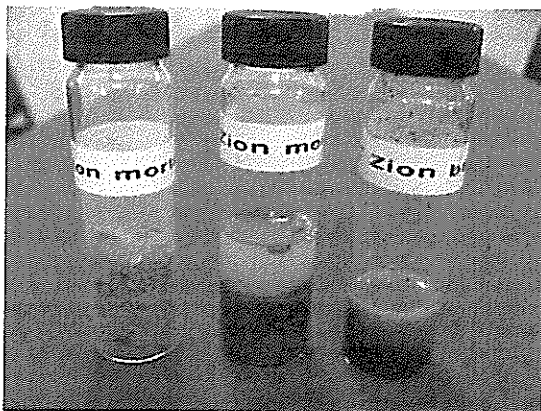
A sample of mortar was crushed to view the aggregate and silt colors for comparison against soil from the site. After a few gentle washings, soil from under the building and just outside the walls matched it nicely. Thus matching the 1850s mortars using on-site aggregates will be easy.

The crushed mortar is in the middle vial, soil at the right. Mineralogically and color-wise they match.

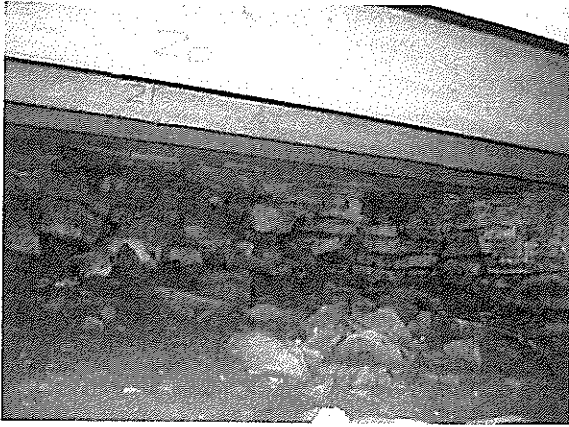
Stones have rolled out of the central section of the NW foundation as the ground beneath has subsided, reducing the compression on this wall.

1.) Relay stones that have rolled out of the foundation and grout all foundation voids.

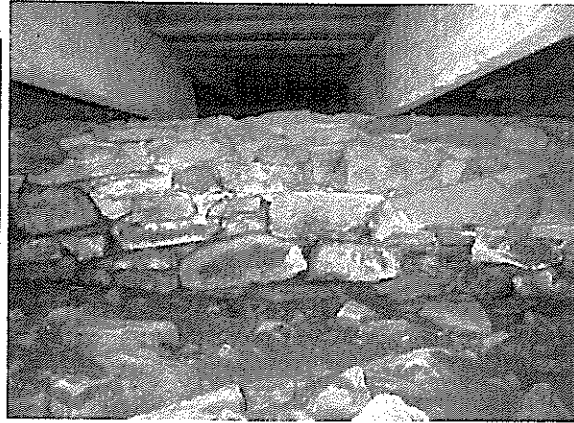
Looking at one of the internal stone walls the downward slide of the wall following the subsiding soil is easier to visualize. At the left of this photograph is the second joist in from the NW foundation wall.

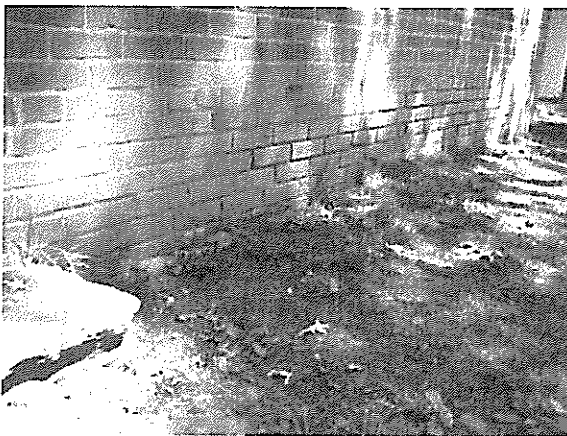
Between the entrance doors, the grade is quite high on the bricks. The building was constructed to have only non-porous stone in contact with the soil. As a result of being regularly wet, the mortar at the base of the wall has begun to fail.

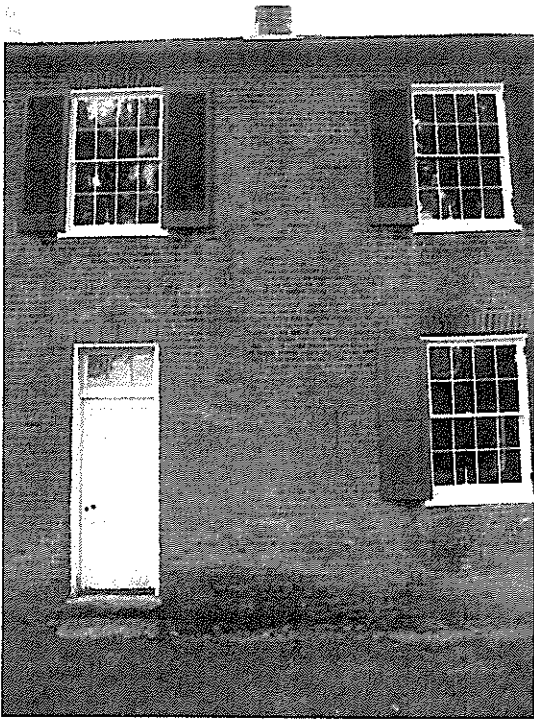
On the East or road-facing elevation, the failing gutter near the chimney feeds water down the wall, leading to algae growth. This is exacerbated in areas by portland re-pointing low on the building. Again, the bricks are in the dirt and a trough of water runs the length of the wall.

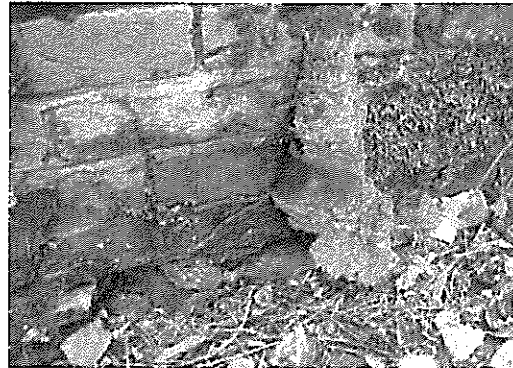
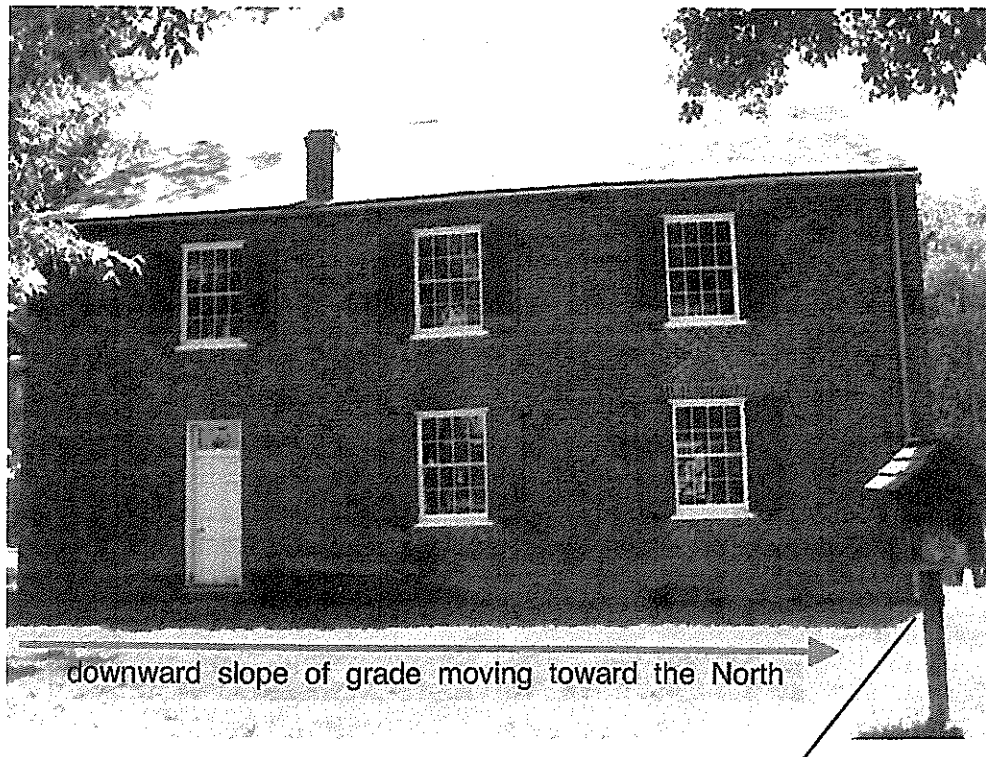
Downspout empties into a ground depression at North corner of building

The cemetery wall acts as a barrier, trapping water against the base of the NW wall. This coincides with being one of the lowest drainage points in the grade. Most of the church property is already draining toward this location from the South.

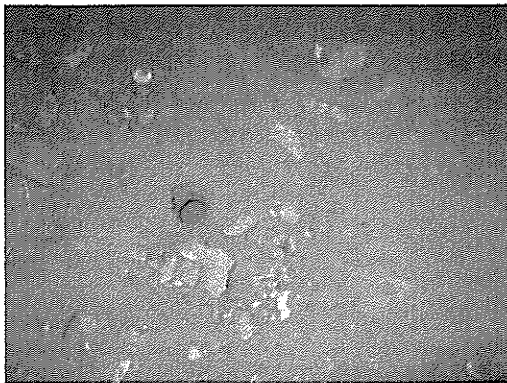
While working on the NW wall we noticed that the ground had a number of small holes in it and seemed slightly soft. Once we got under the floor, we noticed it too was littered with these approximately two inch holes. Is there a mole population softening the soil and helping to contribute to subsidence of the waterlogged soil on the NW end?

Although the soil under the house seems wet, this appears to be due predominantly to condensation. The installation of vents during the last century has magnified the humidity under the floors by allowing the space to experience the drastic spring and winter fluctuations in humidity and temperature that leads to water condensing on cold surfaces. On the South end of the building, however, the soil is significantly wetter. This appears to be due to the higher grade around that end of the building.

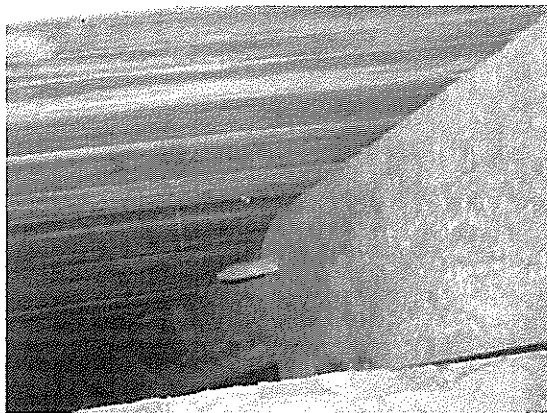
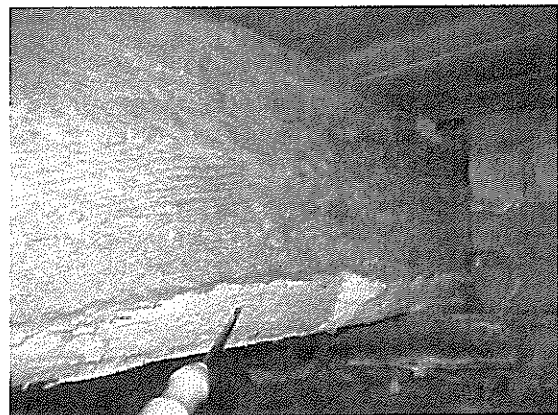
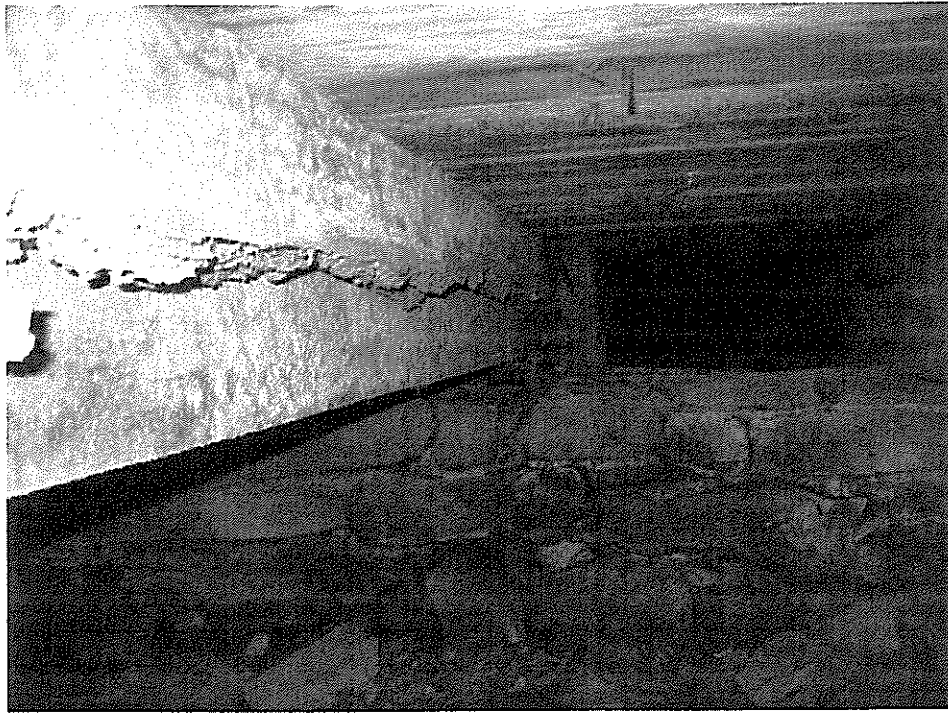
The overlap of joists occurs at the two under-floor stone walls running lengthwise through the building to divide it into thirds. At those intersections, the joists are pinned. Termites have traveled along the bottom of a few joists out from the wall a short distance, normally where there were still remnants of tree bark that are highly digestible. The termites tested out the top edge of several joists, but without causing serious damage to the joists. All joists are tight to the flooring above and seated firmly on the walls. Visible damage is the extent of damage. In other words, an ice pick could not be driven deeper into the joists beyond the damage seen in photographs.

Termites require daily water, so only wet areas can maintain them.

Although earlier joists had been attacked by termites, adequate replacement or sistering with large oak joists has already been addressed. These joist repairs have good bearing on the outside walls and the internal stone walls, bear tightly against the flooring above and maintain the same overlap at the interior wall, including pinning the two joists together.

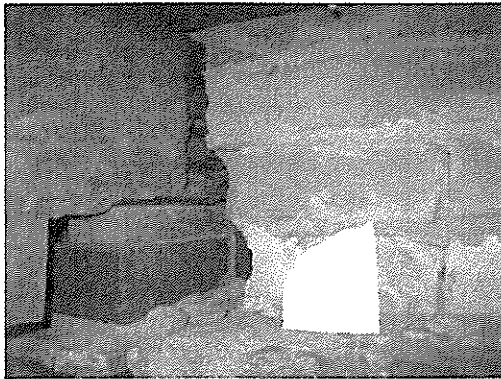
The most undermined joist pocket. Termites attacked the section of joist that sat in the brick wall. In this section of the building, the brick walls are below grade, leading to regular saturation. Although the damage in the wall looks bad, it is superficial, going only as deep as it looks.

An ice pick could not be driven any deeper into the joist at the pocket in the wall or at any other point along its length. Even assuming the section in the brick wall was fully deteriorated, the joist still has more than 3" of bearing on the stone foundation.

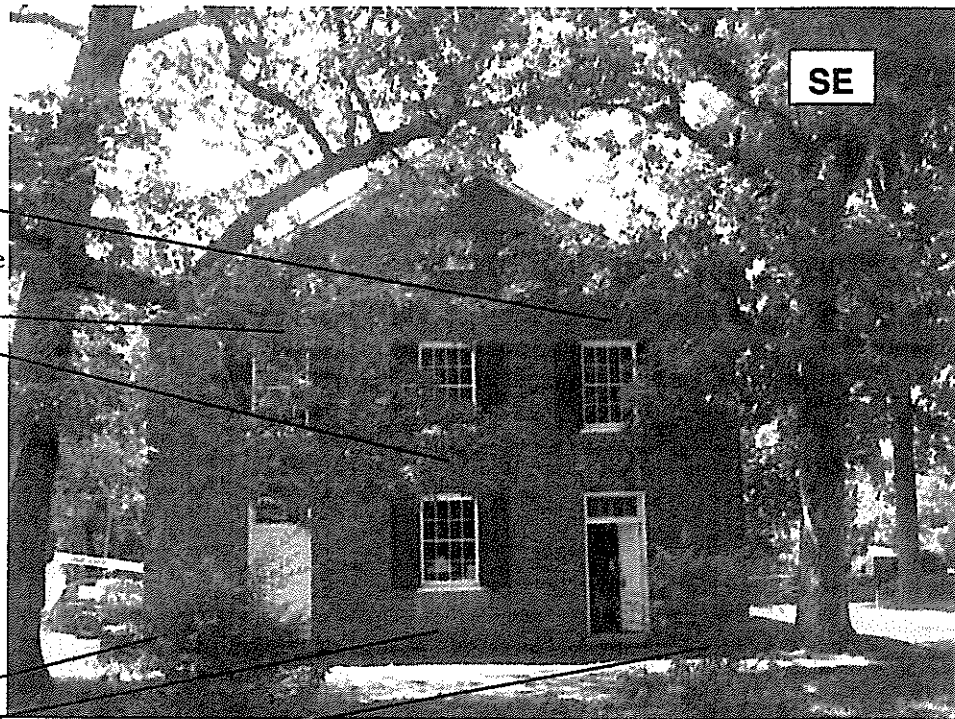
SE

Mortar failure related to high grade.

Foundation on entrance elevation is full submerged, leaving bricks to bear brunt of uphill water and weathering.

Wall deformation greatest between windows, both vertically and horizontally.

4' long cracks over right window should be repaired

4' long cracks need to be repaired in lime mortar

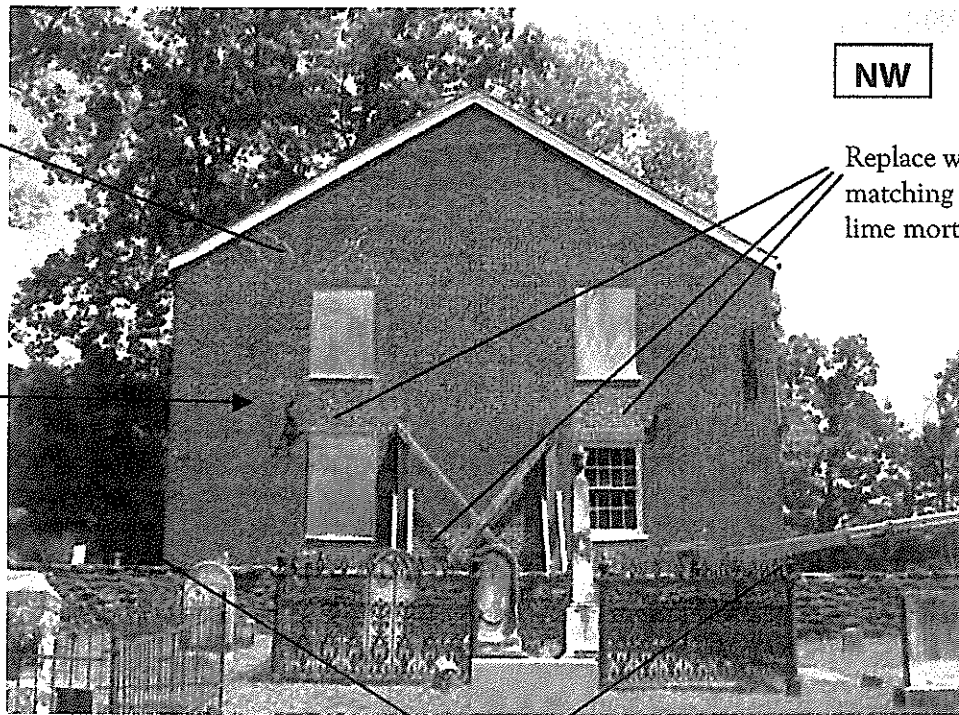
All roof water empties in two downspouts on this end. Downspouts dump at base of NW wall. This water joins with all upland water from the South in pooling against the cemetery wall.

Masonry collapsed
due to original
design flaw :
trusses bear here

Gutter failing;
spilling water
onto wall below

Lower wall repointed
in portland cement
that traps water in wall

Failing gutter has
created a depression in
the ground that fills
with rainwater

Replace with matching lime mortar

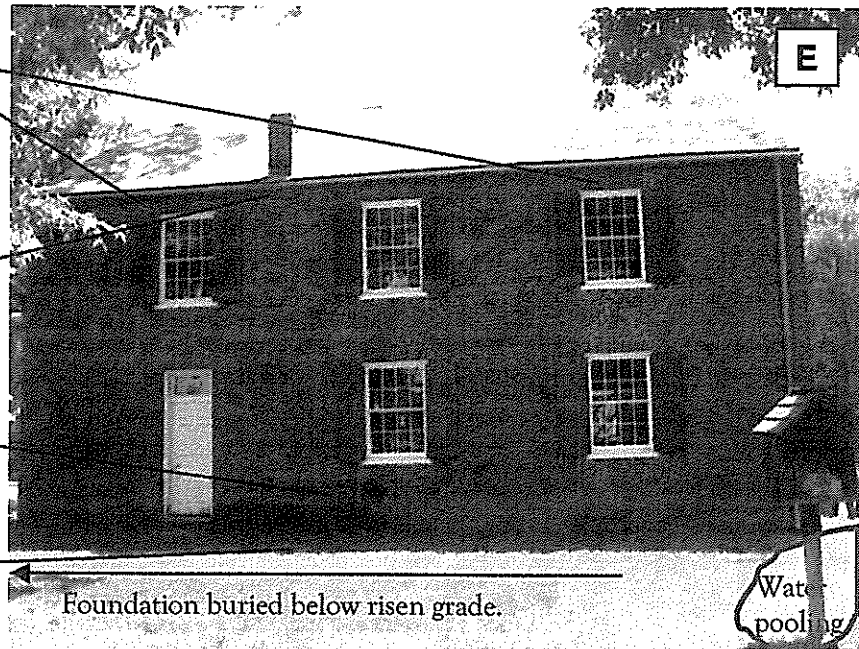
Foundation buried below risen grade.

Water
pooling

Road-facing elevation has many water issues. Upland water washes past and into a ground depression that runs the length of the wall. Gutter failure below the chimney feeds water down the wall. Inappropriate portland cement pointing repairs where the mortar has been washed out of joints due to splash-back from the leaking gutter is now causing the lower wall right of the door to remain constantly wet. The result: heavy algae growth outside and a wet crawlspace inside.

Downspout dumps
at base of wall

Repair in lime mortar

Crack behind
downspout to be
repointed in lime

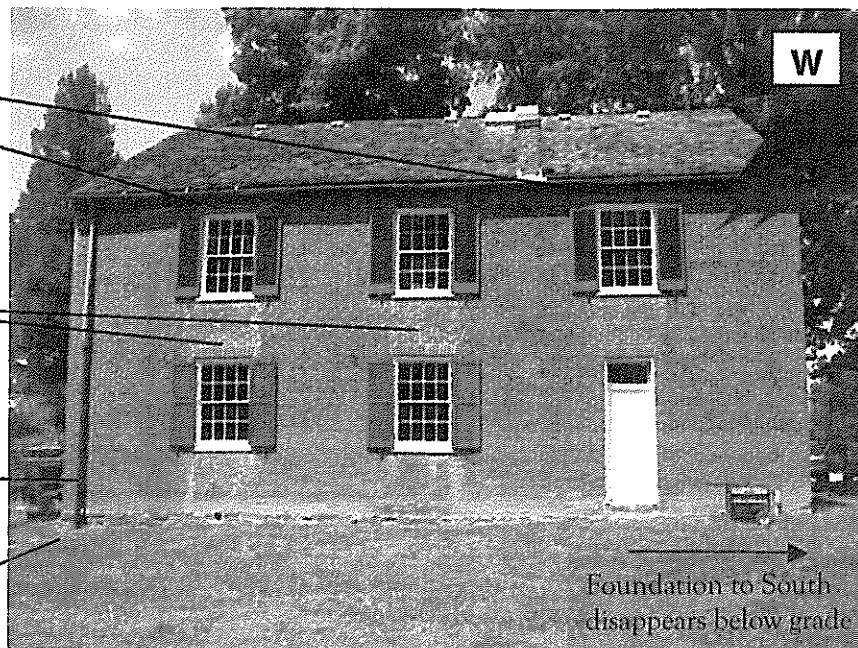
Foundation to South
disappears below grade

The rear elevation has positive drainage to the treeline at the back of the property.
